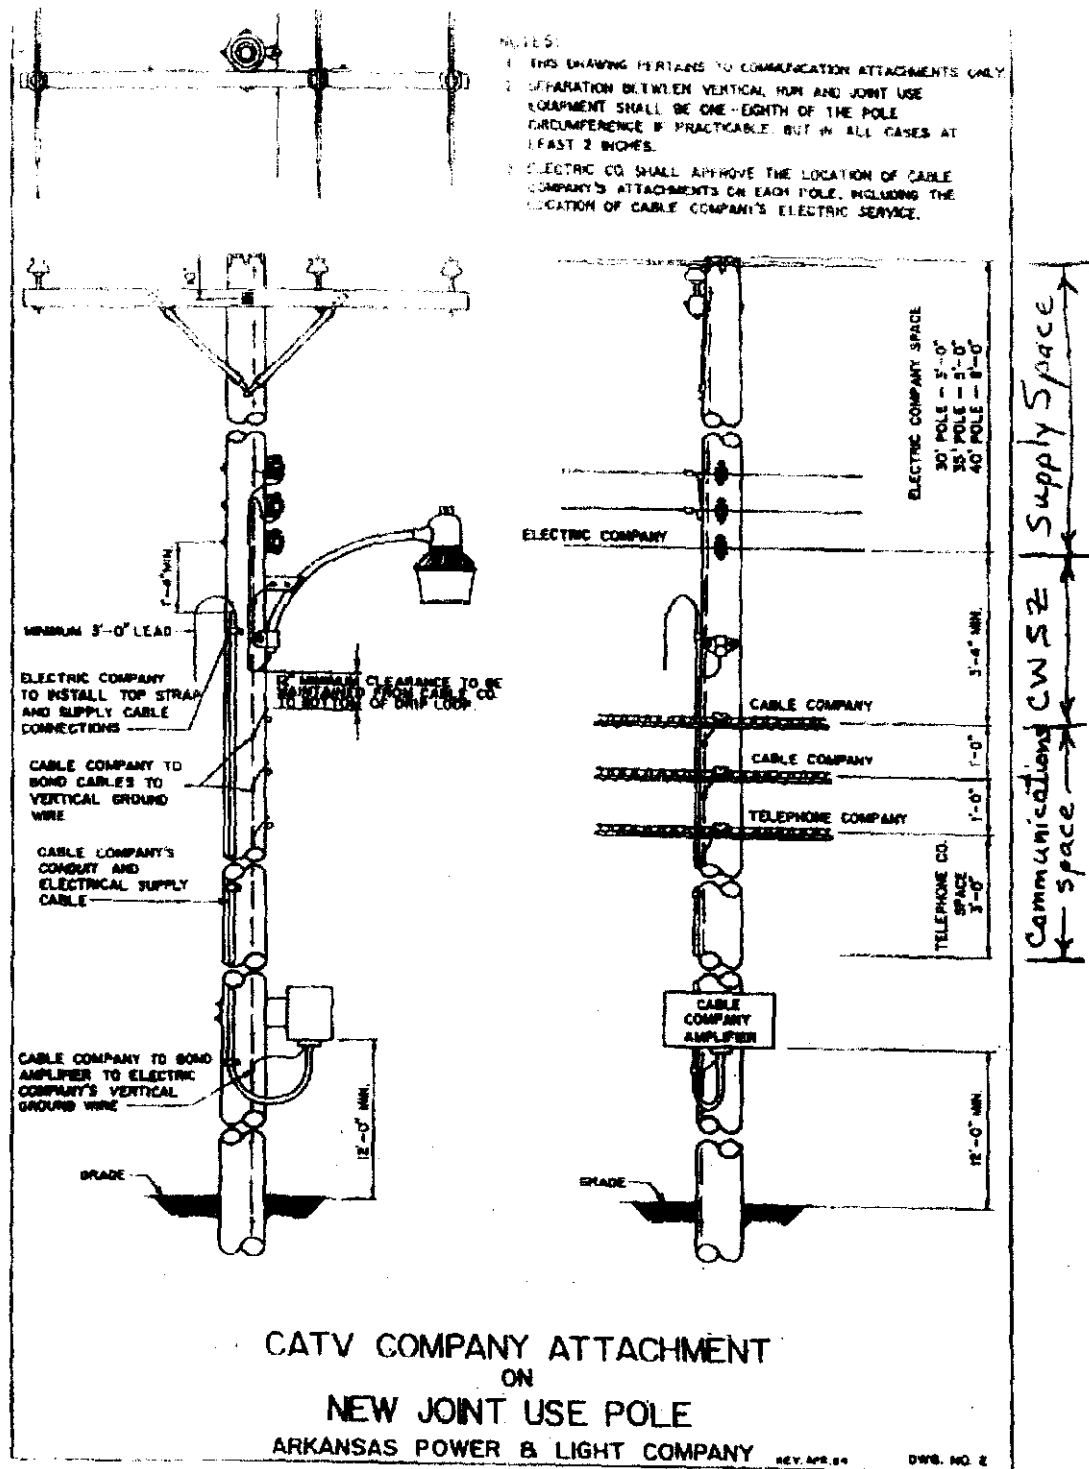
-- 20A --

This diagram which is attached to at least some EAI pole agreements shows a standard EAI pole space allocation. This allocation includes five feet of communications space, a 40-inch communications worker safety zone ("CWSZ") and eight feet of electric supply space for a 40-foot pole. (The hand-written notes in the right margin are mine.)
